DEPARTMENT OF TRANSPORTATION**DIVISION OF ENGINEERING SERVICES**

Contract #: 04-0120F4Cty: SF/ALA Rte: 80 PM: 13.2/13.9File #: 1.28**WELDING INSPECTION REPORT****Resident Engineer:**Siegenthaler, Peter**Address:** 333 Burma Road**City:** Oakland, CA 94607**Report No:** WIR-023963**Date Inspected:** 26-May-2011**Project Name:** SAS Superstructure**OSM Arrival Time:** 700**Prime Contractor:** American Bridge/Fluor Enterprises, a JV**OSM Departure Time:** 1730**Contractor:** American Bridge/Fluor Enterprises, a JV**Location:** Job Site**CWI Name:** See Report Below**CWI Present:** Yes No**Inspected CWI report:** Yes No N/A**Rod Oven in Use:** Yes No N/A**Electrode to specification:** Yes No N/A**Weld Procedures Followed:** Yes No N/A**Qualified Welders:** Yes No N/A**Verified Joint Fit-up:** Yes No N/A**Approved Drawings:** Yes No N/A**Approved WPS:** Yes No N/A**Delayed / Cancelled:** Yes No N/A**Bridge No:** 34-0006**Component:** Orthotropic Box Girders**Summary of Items Observed:**

A). Lifting Lug Holes

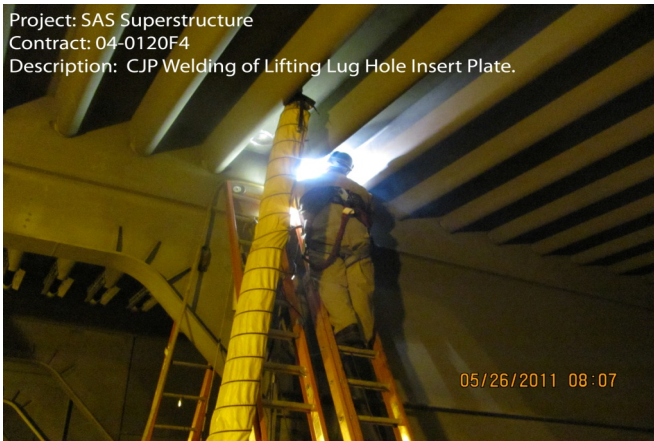
The QAI observed the CJP welding of the lifting lug holes identified as WN: 8E-PP68-E4, W2 & W4 and WN: 9E-PP76-E3, W2 & W4. The welding was performed by Jason Collins ID-8128 and Jorge Lopez ID-6149 utilizing the WPS identified as ABF-WPS-D15-1110A, Rev. 1. The QAI also observed the QC inspector perform the visual inspection and verify the welding parameters during the production welding. The inspection performed by Fred Von Hoff appeared to comply with the contract specifications.

The welding was performed in the overhead position utilizing the E7018-H4R low hydrogen. The 3.2 mm and 4.0 mm electrodes were stored in electrically heated, thermostatically controlled oven after removal from the sealed containers. The exposure limits of the electrodes appeared to comply with the minimum storage oven temperature of 120 degrees Celsius as per the contract documents. The WPS's were also utilized by the QC inspector's as a reference to monitor the welding operation, verify the welding parameters and verify the minimum preheat and the interpass temperatures. The welding parameters and surface temperatures were verified by the QC inspector's utilizing a Fluke 337 clamp meter for the electrical welding parameters and Tempil Heat Indicators for verifying the preheat and interpass temperatures. At the time of the observation no issues were noted by the QAI.
